THE UNITED STATES ARMY BOARD FOR AVIATION ACCIDENT RESEARCH • FORT RUCKER, ALABAMA

## CH-34 AND CH-37 ACCIDENT SUMMARY

1 July 1966 through 30 June 1967

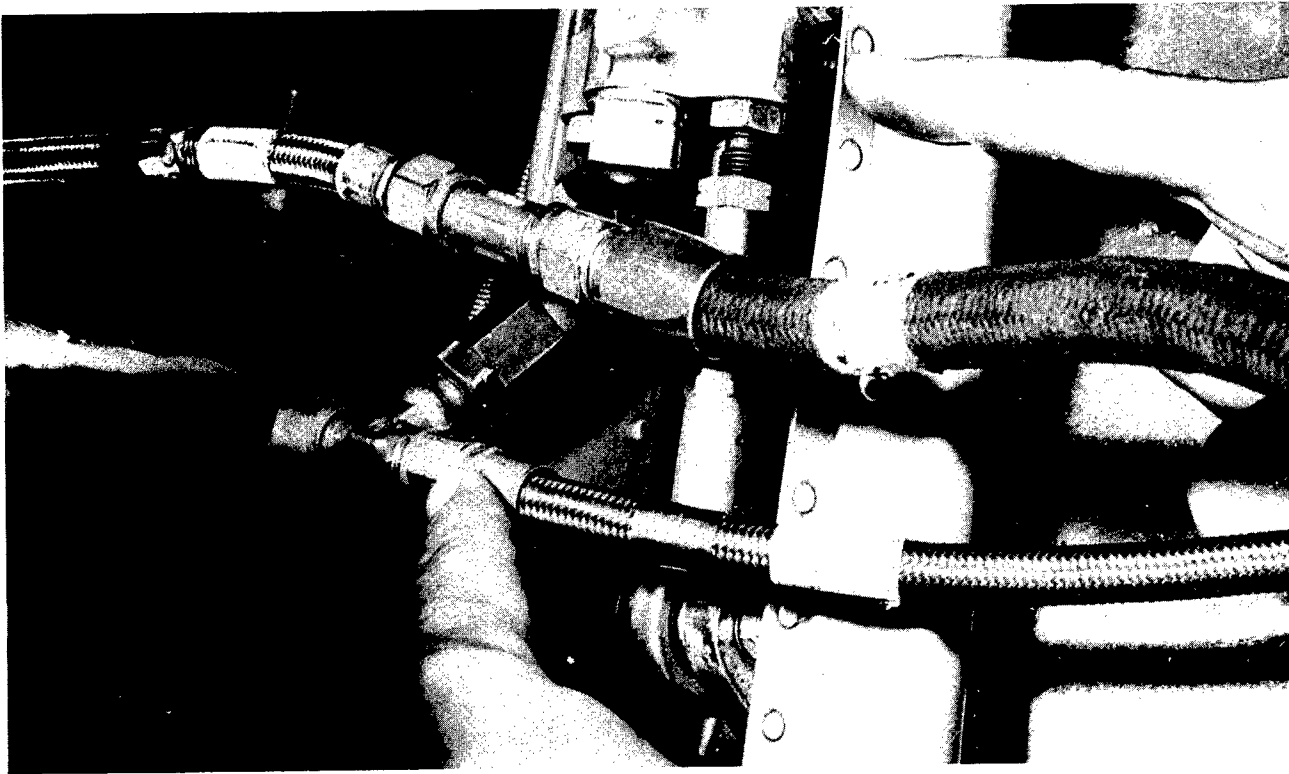
**F542**—Accident occurred during ground runup phase of a maintenance test flight to check out replacement of a left lateral primary servo. Preflight was accomplished with no discrepancies noted. Engine was started and warmup was normal. Rotor was engaged, but two attempts were required to complete engagement. RPM was established at 1700-1800 and maintained to allow clutch to drain, then a flight control check was made. The cyclic was moved fore and aft and during forward movement, the collective pitch moved upward about 3 inches. Primary servo was turned off and cyclic was moved about again, but no difficulty was encountered. Servo selector switch was moved from "primary off" to "both" to "auxiliary servo off." When the auxiliary servo was switched "off," the collective pitch began to rise. Pilot was unable to push the collective down, and attempted to close throttle to reduce rpm while applying down pressure on the collective. Aircraft became light on its main

landing gear, moved slightly rearward and left, and rolled over on left side, damaging tail rotor, tail pylon, main rotor blades and head, and three bell-crank assemblies. Pilot had minor injuries. Caused by improper installation of primary servo system pressure and return hydraulic lines. The low pressure hydraulic return line from the hydraulic reservoir was attached to the high pressure port of the left lateral servo, while the high pressure line was attached to the low pressure port of the left lateral servo. Other causes were (1) local maintenance supervisor did not adequately supervise or properly check completed installation of the left lateral primary servo, including pressure and return lines, (2) technical inspector failed to detect the incorrect installation and accepted installation, (3) neither the crewchief nor the maintenance test pilot detected the incorrect installation during preflight, and (4) use of improper technique in overcoming malfunction.

**F542** Collective could not be lowered due to improperly installed primary servo system pressure and return hydraulic lines.

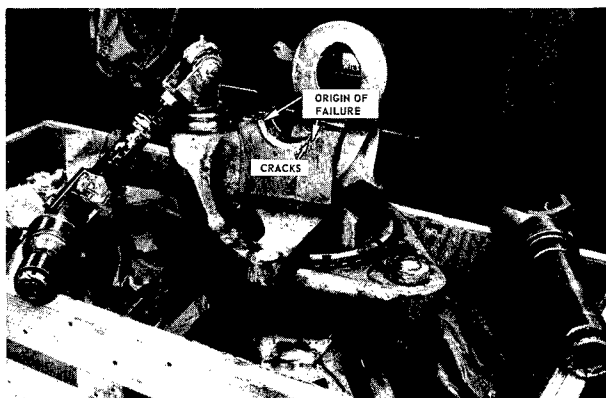
**H798**—Two CH-37Bs were flying at about 600 feet en route to destination. After 2½ hours, the lead aircraft began descending and turning left from 210° to 150° at a rate consistent with a normal landing approach. Rate of descent increased greatly at about 100 feet, and rotor assembly and transmission seemed to separate from aircraft about 15 feet above the ground. Aircraft, which was in a nose low attitude, was consumed in a ball of fire on or just prior to impact and was destroyed. Pilot, copilot, and crewchief killed. Caused by (1) fatigue failure of rotor head spindle through the aft pin hole, occurring from low overstress fatigue mechanism induced by high residual tensile stresses around outside hole periphery, and (2) lack of quality control.

**H798** Rotor assembly and transmission separated from CH-37B due to fatigue failure of rotor head spindle and lack of quality control.
